Secondary Belt Feeders

Feeding - 14" Shot Rock at 800 TPH

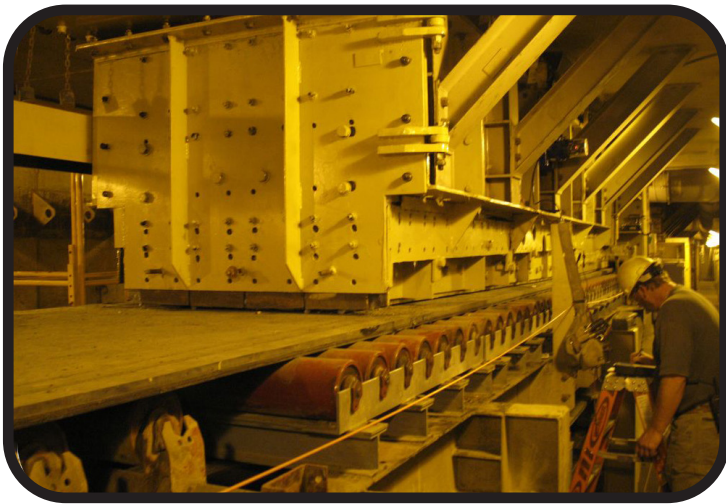
These feeders were fitted with an internal Loading Shoe and a Roller Table.

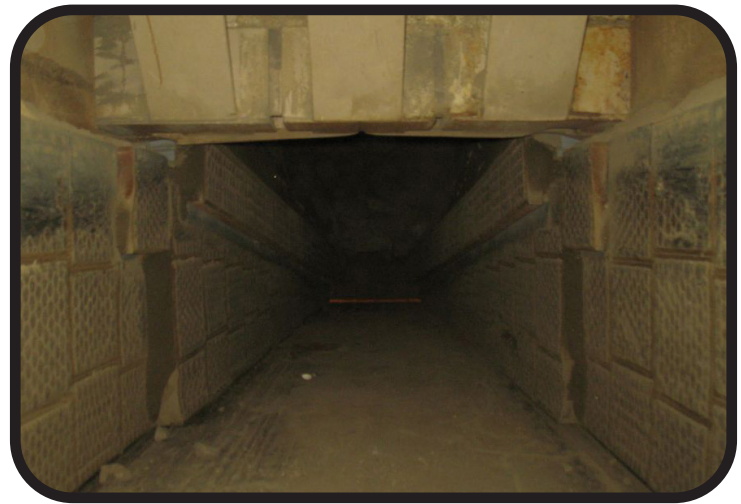
Internal Loading Shoe is fitted with ceramic liners on the Feeder Walls. Strike-off bar is overhead.

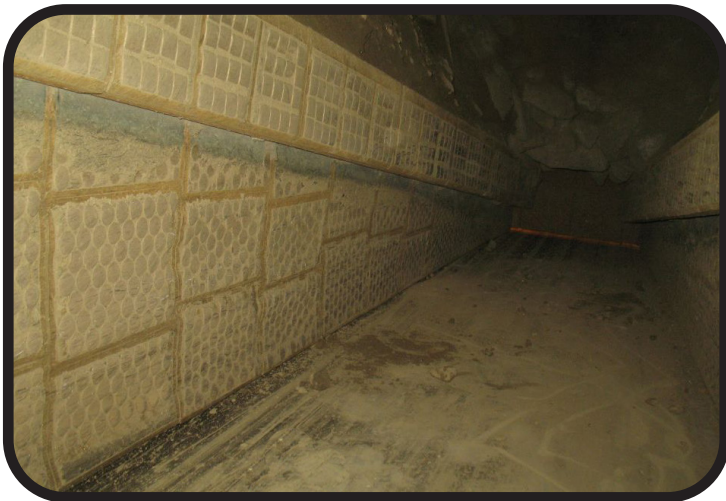
Looking toward the tail of the Loading Shoe. Top left is the engineered ceramic Deadbed Bar that protects the tapered floor of the Shoe.

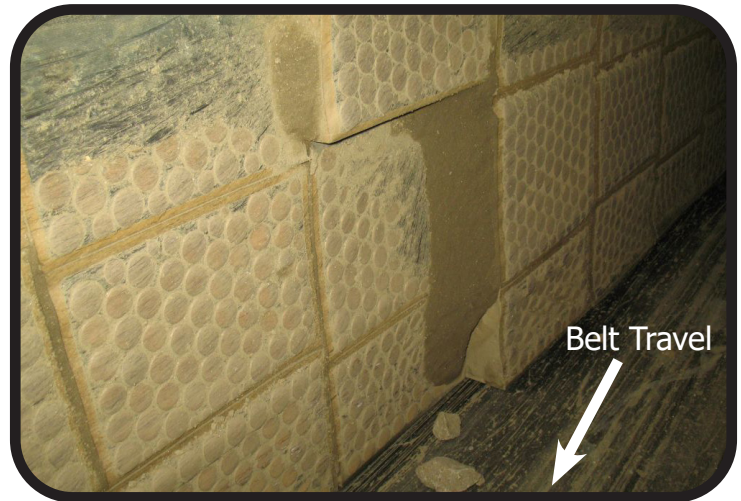
Special geometry is used effectively to relieve the side pressures on the liner package. The liners on the right hand side are inside the Shoe.

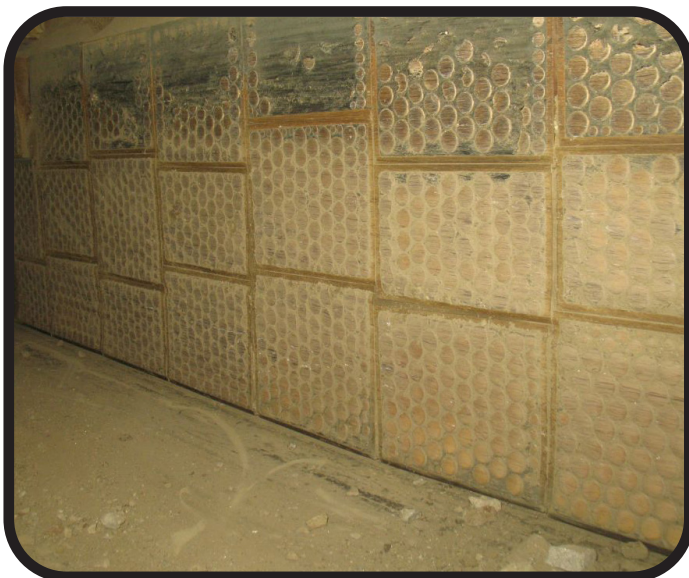
Discharge Zone

The discharge zone liners are in excellent condition. These now have an operating lifecycle of 3-5 years. Previously, 2" Hardox 600 liners had a 90 day lifecycle.

The Rubber-Ceramic Liners in this area are held in place with two 1" mounting bolts, attached from the outside of the feeder. This provides a smooth face for uninterrupted material flow out of the feeder. Liner weights are held to manageable limits for removing by hand.

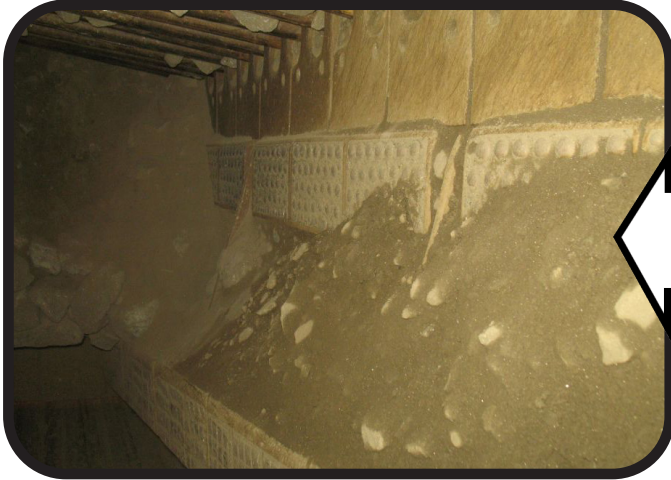
Top view of the Loading Shoe; oversized rocks are wedged in the tail section. Proper Deadbed of material.

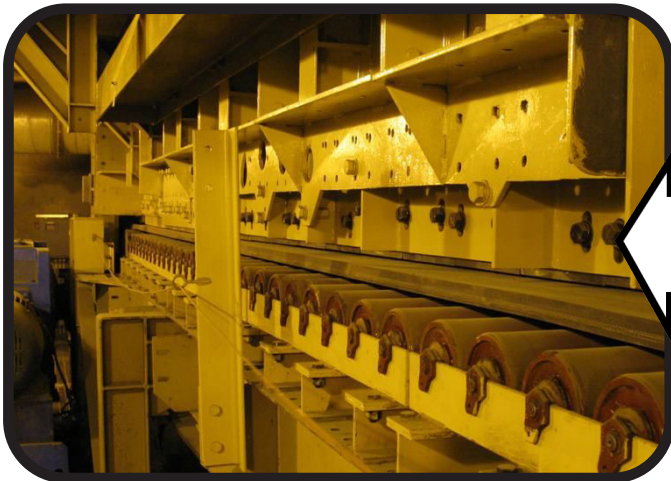
In this example the outside walls were kept in place and a new Roller Table was fitted under the belt. These frames can be withdrawn by two men for roller servicing.

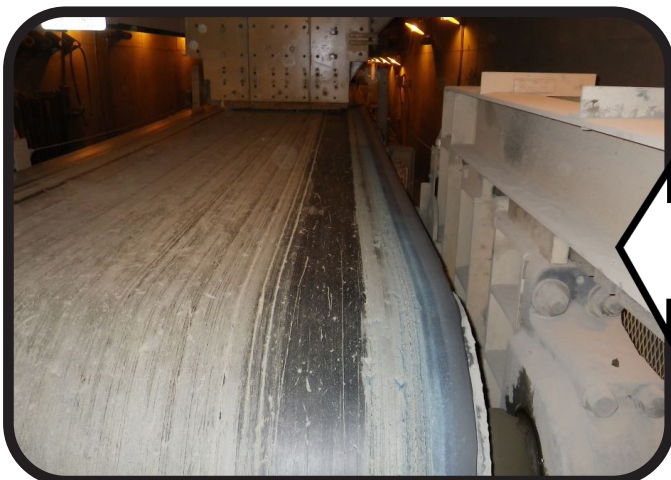
Belt life is drastically improved from 90 days to now over three years...and still going! (This belt was not replaced during the installation of the new upgrade.) Notice the polished smooth top cover that tracks under the new ceramic liners in the Loading Shoe. After three years, it is still unknown how long these belts may ultimately last.

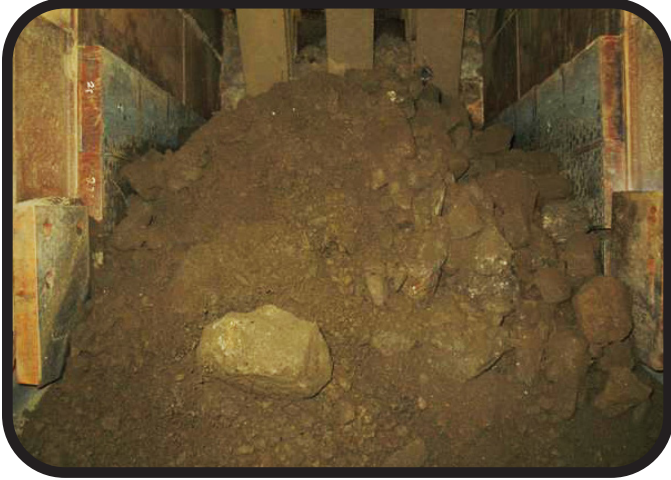
800 TPH of primary crushed ore.

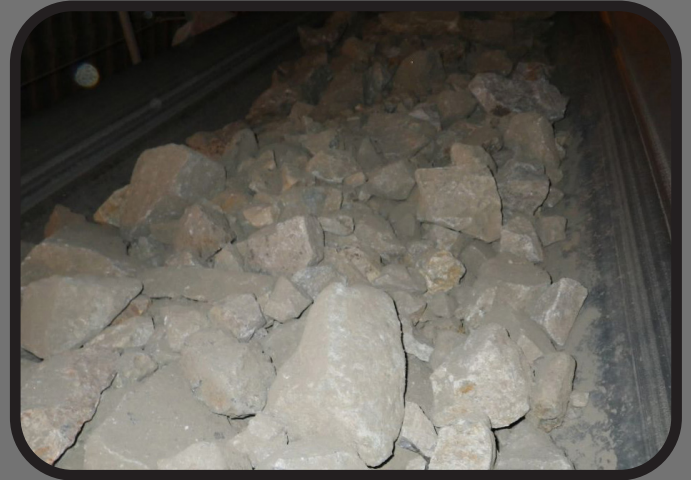
Approximately 1,600 TPH of SAG mill feed.
The rocks are sharp, hard and angular.

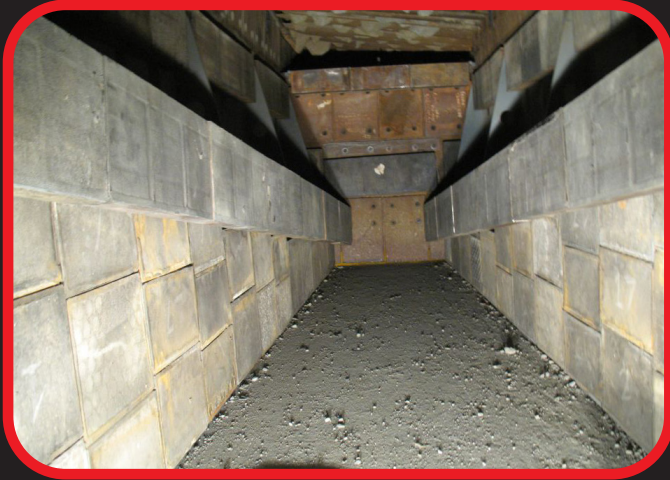
Completion of Installation

(Left) The liners on the back wall were left as steel on this retrofit. Notice the rubber skin is covering the ceramic embedded liners in both the Deadbed Bars and the Loading Shoe Wall liners. These liners are custom designed for this feeder application and specific internal steel gusseting, attachment hardware points and retaining steel for the ceramic. Overhead, 2" diameter splice bars.

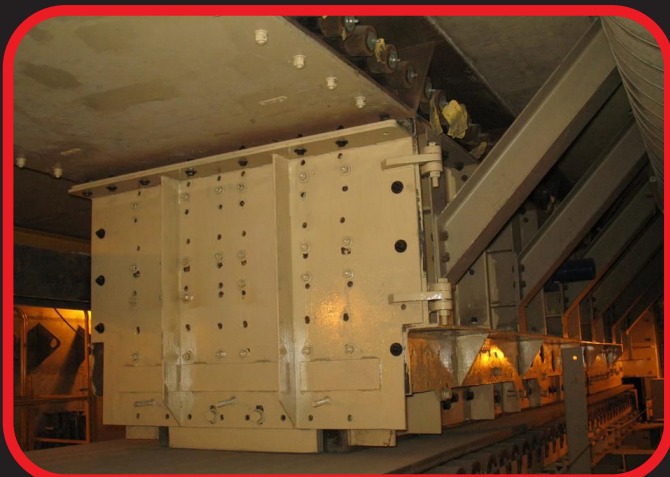
Converted Feeder viewed from the back

(Left) The top of the photo is the plate floor, installed to shorten the excessive length of the feeders. Back door was slightly modified. New Loading Shoe walls can be seen inside the bottom of the trimmed feeder walls. The new Roller Table now evenly and fully supports the belt, eliminating the pinching of material under the liners.
